Version 6.3 Service Pack 2 Release Summary
July 2006

Overview

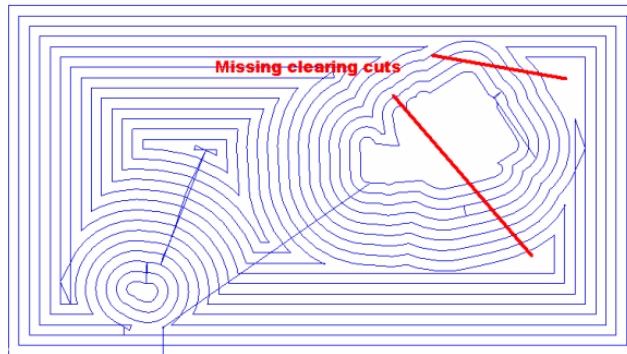
Above is an example of a single level of a clearing program created in Version 6.3. In 2 areas of the level, clearing cuts were missing. This has been corrected to insert the needed clearing cuts to completely clear each level as shown below:

Spiral clearing has been revised to ensure each level of the program will be completely cleared before proceeding to the next level. This correction addresses discrete cases reported in Version 6.3 where one or more levels would omit some of the clearing cuts. This can result in leaving standing stock or the tool will encounter a heavy stock condition when the area is cleared at a lower level.

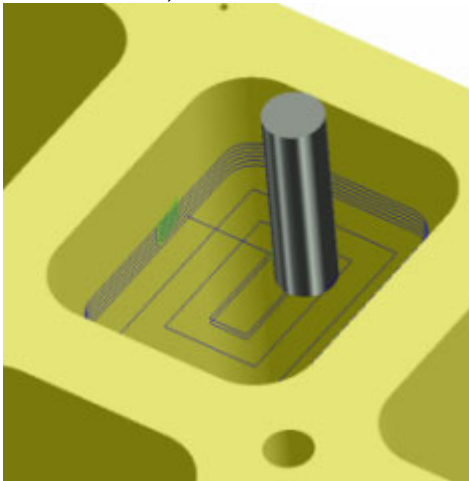
In a discrete case, several levels of a Z-Planar program omitted the clearing cuts entirely:

Part way through this program, the interior clearing cuts were omitted for several levels. Only the outer boundary was cut for these levels.

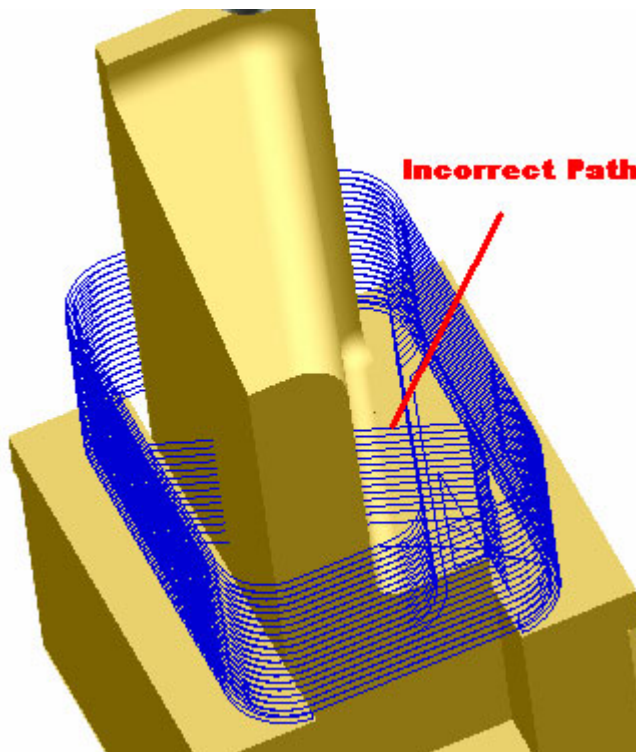
When moving to the start point of the next level, the cutter path would feed through the part data instead of choosing an interference-free path:

On just certain levels of this job, the program does not use an interference-free path to return to the start.

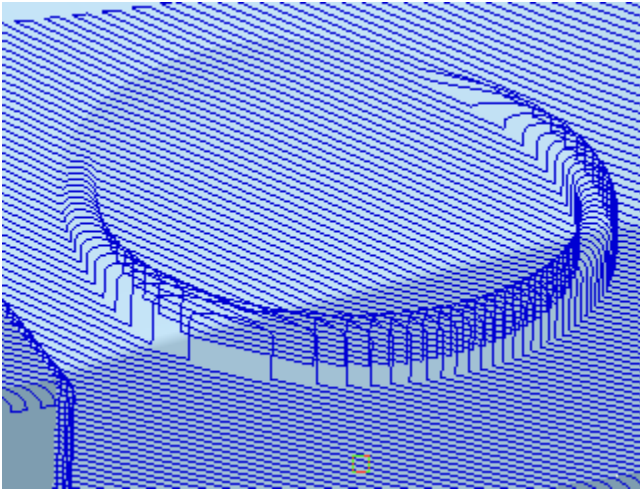
A discrete problem with certain periodic surface definitions allowed by Parasolid data could affect lace cutting:

The definition of the underlying periodic surface caused this lace cut to lift instead of staying on-surface.

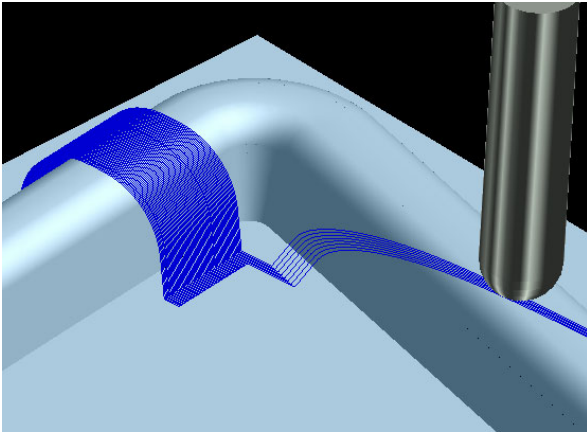
In discrete cases where there is an abrupt change in the direction of radial curves, the software could fail to produce the proper cuts. An example is a sharp corner as shown below:

In the corner of this part, the radial program doesn't follow the inside corner of the radial curve. It wrongly continues on over the part until it intersects the curve.
